**PAJARO RIVER WATERSHED
FLOOD PREVENTION AUTHORITY**
Phase 4b: Implementation Plan for Soap Lake Floodplain
Preservation Project and Watershed Flood Protection Actions

Technical Memorandum No. 4.4.4

Task: Evaluation of Gage Rehabilitation Options
To: PRWFPA Staff Working Group
Prepared by: Eric Evans
Reviewed by: Lidia Gutierrez, Dr. Jeff Lewandowski
Date: March 31, 2005
Reference: 0053-004.4

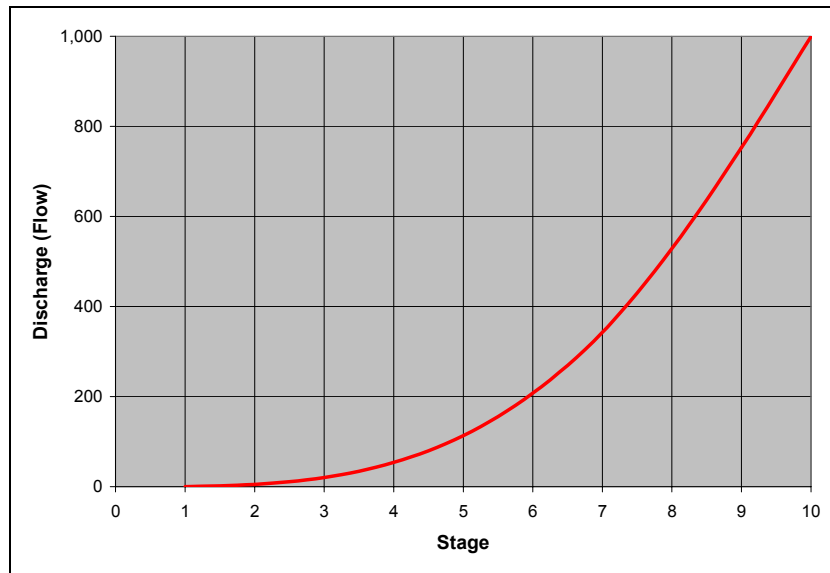
Figure 2: Example rating curve.

Streamflow measurement based on stage is therefore a two step process. First, stage is measured either directly at surface or by the water pressure at the bottom of the channel. The stage is then translated into its corresponding streamflow by using a predetermined mathematical relationship. This relationship is commonly known as a rating curve. An example rating curve is presented in Figure 2.

This process must be done during at least three different flows in order to define the nonlinear curve shown in Figure 2. Measurement of more than three flows will improve the accuracy of the curve.

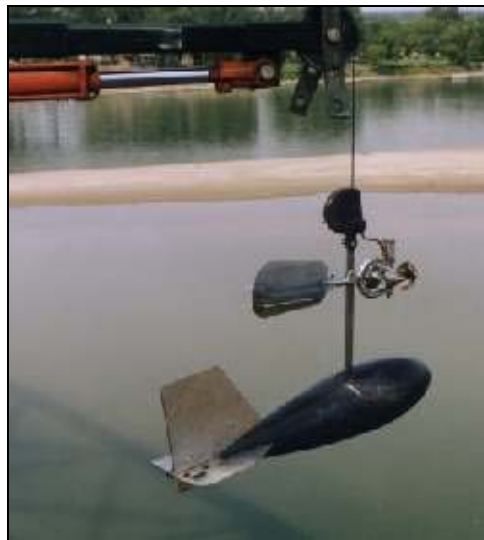
Figure 3: Example current meter used to measure water velocity.

Development of a rating curve at a particular location along a channel can be accomplished by measuring the velocity of the water at several different depths and positions along the width of the channel at that location. A commonly used device for measuring local water velocities in this manner is a current meter. An example current meter is shown in Figure 3.

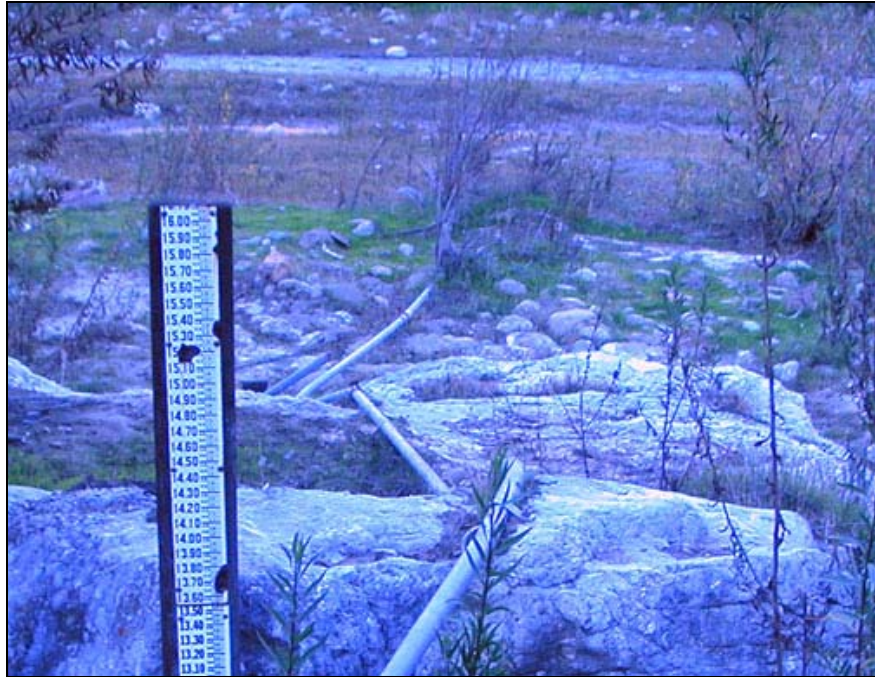
Figure 4: Staff Gage on the San Benito River (SB WC).

Staff gages are almost always located near a more sophisticated measuring device in order to verify the device's accuracy. An example staff gage is shown in Figure 4. This staff gage is located at the San Benito River near Willow Creek School (SB WC) in conjunction with a bubble gage and satellite transmission equipment. The river at low flow is visible in the background. Conduit running from the instrument shelter to the low flow channel is visible to the right.

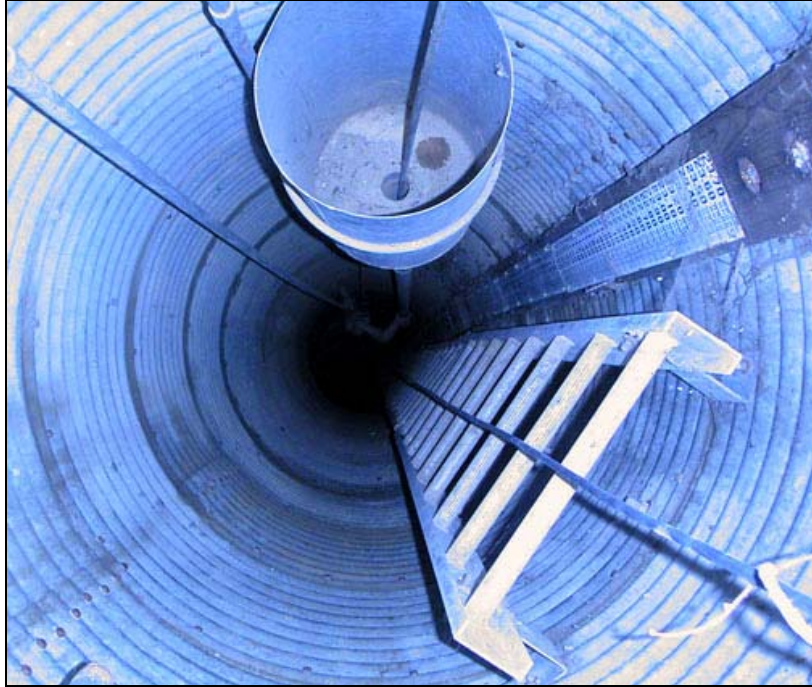
Figure 5: View inside of stilling well (Pacheco Creek).

A view looking down into a stilling well at Pacheco Creek near Dunneville, CA (Pacheco) is shown in Figure 5. An access ladder and internal staff gage are visible. The bucket acts as a funnel to receive water for flushing sediment out of the pipe that hydraulically connects the well to the bottom of the creek.

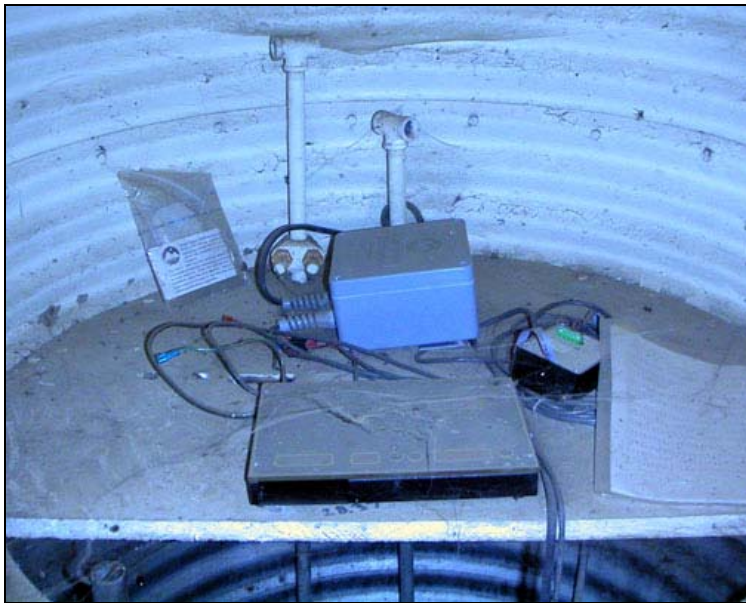
Figure 6: Pressure transducer equipment in a stilling well (Pacheco).

An advantage of pressure transducer systems is that they can be easily installed into an existing stilling well system. The stilling well provides sturdy pipe conduit for positioning the probe at the channel bottom. The instrument shelter built into the top of a stilling well can house supporting electronic equipment such as the blue metallic desiccant box shown in the center of the photo in Figure 6. The transducer and appurtenant equipment shown in the picture have been abandoned in place since 2003. The site never had radio transmission equipment, and its solar panel had been removed.

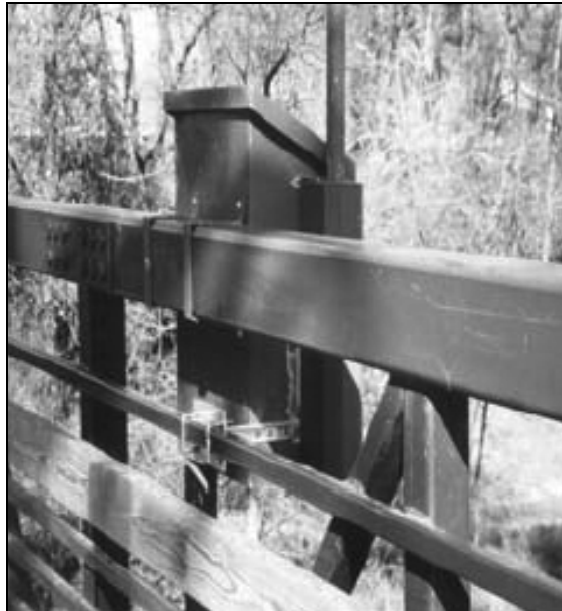
Figure 7: Sonic downlooker.

Sonic downlookers measure the stage of a channel by using high frequency sound waves similar to the sonar system of bats. A stand alone unit containing a solar panel and transmitter can be mounted to the side of a bridge where its sonar transmitter and receiver can “look” downward to measure the water surface elevation (see Figure 7).

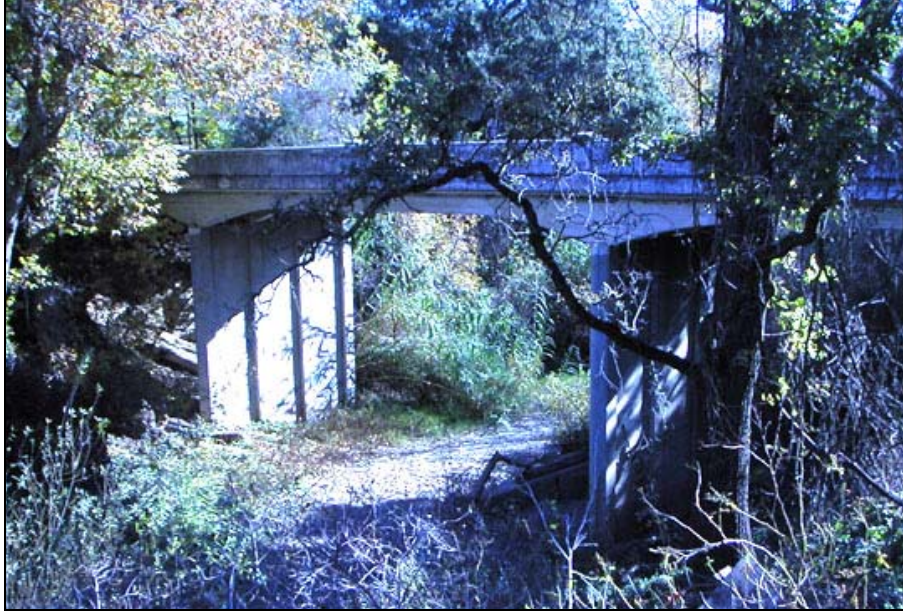
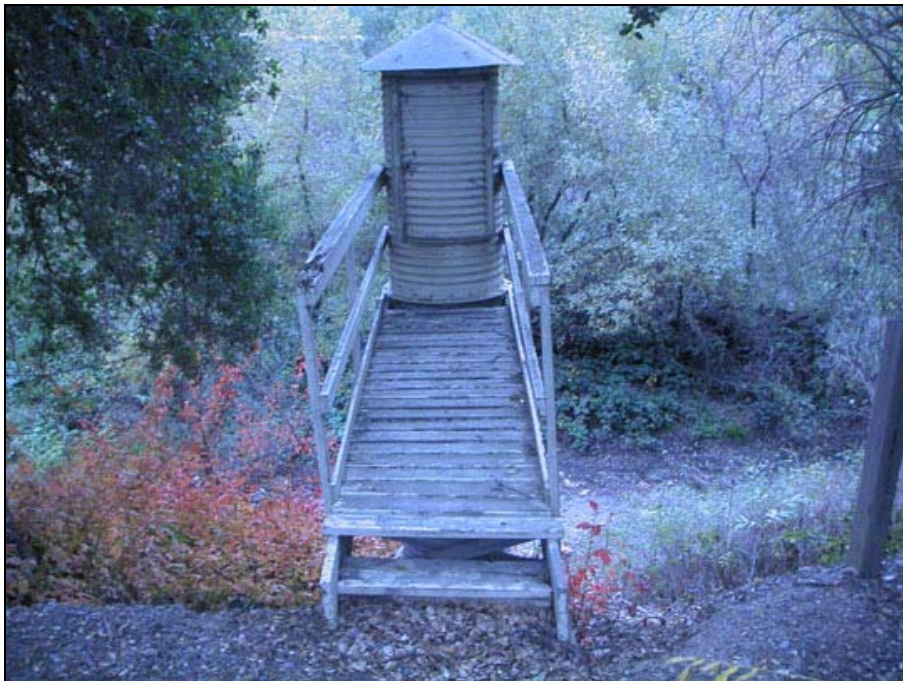
The Pacheco site has a stilling well structure and is located along Highway 152 in southern Santa Clara County just north of the border with San Benito County (see Figure 1). It can be visited by taking the Walnut Avenue exit from Highway 152 and parking near the Walnut Avenue bridge which crosses over Pacheco Creek a few hundred yards from the highway exit. The gage is located approximately 450 feet downstream from the bridge on the right side of the creek as one faces downstream. Photos of the Walnut Avenue bridge and the gage's instrument shelter are shown in Figures 8 and 9.

Figure 8: Walnut Avenue Bridge (facing downstream)

Figure 9: Pacheco Creek Gage Site

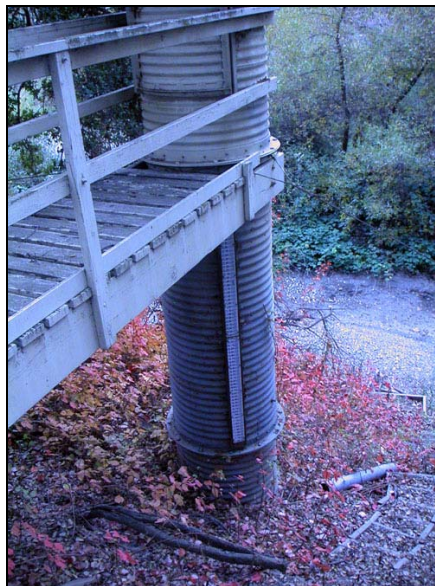
Figure 10: View of Pacheco Creek stilling well structure.

The first streamflow recording system at this location was a stilling well formed by a 36-inch corrugated metal pipe installed vertically in the streambank. The top part of the pipe serves as the instrument shelter for the recording equipment and is accessible by a catwalk and locking hatch. Another view of the stilling well is shown in Figure 10. Note the access steps to the bottom of the channel and heavy growth of poison oak. Photo was taken in November 2004 when water was not flowing in the channel.

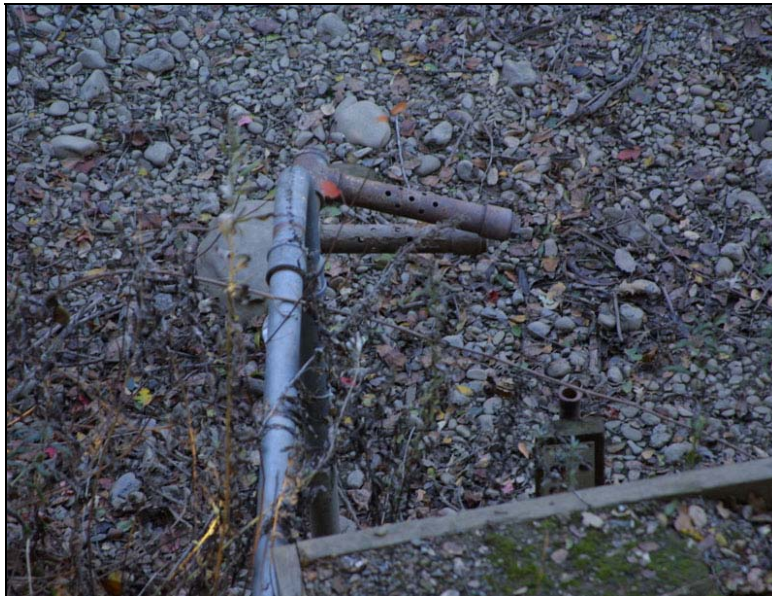
Figure 11: Intake and discharge pipes at Pacheco.

In the year 2000, the SCVWD installed a pressure transducer system at the Pacheco stilling well. A few years later in 2003, the equipment began to malfunction and soon stopped working altogether.

Deficiencies in the installation and/or maintenance of the equipment may have resulted in the failure of the Pacheco gage in 2003. The perforated ends of the original stilling well intake and discharge pipes, where the pressure transducer probe is most likely located, did not appear to be buried in sediment (see Figure 11). The good condition of the wooden access steps and position of the pipes relative to the bottom of the channel are indications of good channel stability.

Troubleshooting and testing of the existing pressure transducer can be done to determine what is necessary for repair. This work can be done in the field or the gage can be sent to the supplier, High Sierra Electronics in Grass Valley, CA. If repair of this equipment is cheaper than its replacement cost, reactivation of the gage and installation of ALERT equipment may be the least costly alternative in

Installation of ALERT equipment and a sonic downlooker or bubbler gage.

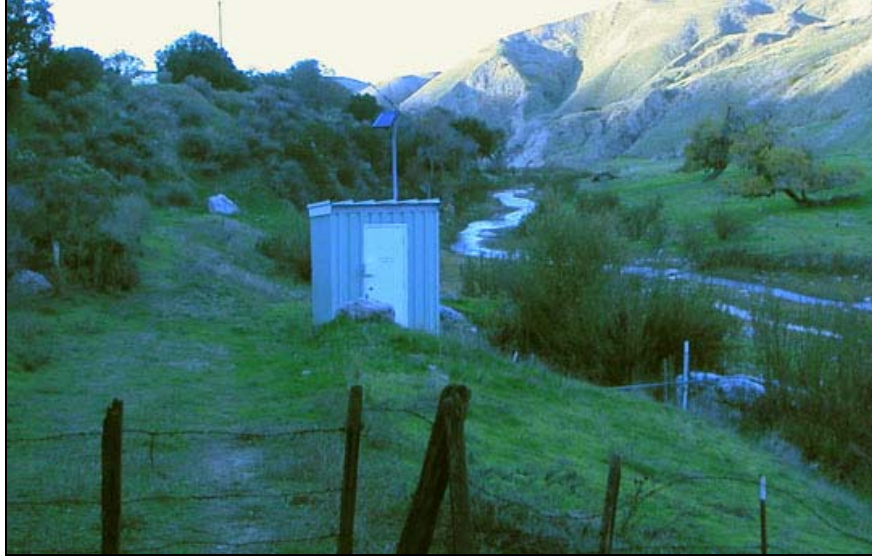
Figure 13: San Benito River near Willow Creek School

Unlike Pacheco, the San Benito River near Willow Creek School gage (SB WC) is a fully functioning gaging station operated by the USGS and is shown in Figure 13. It consists of a bubbler gage, solar panel, and satellite antenna.

The San Benito County Water District is a cooperator with the USGS and shares the operation cost of this gage. The USGS maintains the measurement equipment and rating curve. Installation of ALERT equipment at the site, along with an additional solar panel, is all that is needed and will not result in any additional charges from the USGS.
